Materials and Techniques of *Art Nouveau* Architecture in Italy and Portugal: a First Insight for a European Route to Consistent Restoration

A. C. Dell'Acqua¹, E. Franzoni², F. Sandrolini² and H. Varum³

The results of the investigations on building materials and techniques of Casa Major Pessoa, a typical *Art Nouveau* construction in Aveiro (Portugal), and two coeval *Art Nouveau* buildings in Bologna (Italy) are presented as a methodological contribution to the restoration of this kind of buildings. This is the first step to ascertain the existence of a common thread between local materials, technologies and architecture in European countries at the same period. A holistic approach was adopted: materials were investigated along with architectural, structural and technological features, in order to achieve a first insight into the *Art Nouveau* architecture in Europe in particular for its consistent restoration without loss of historical memory.

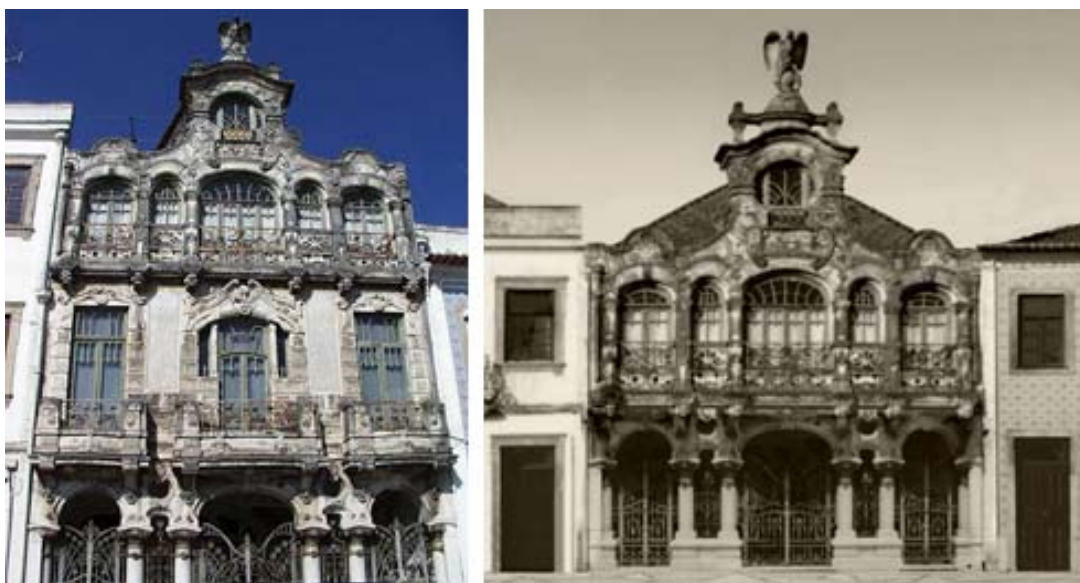
Figure 1: Casa Major Pessoa: south front presently (left) and in 1909 [13] (right)

The *arte nova* decorations in the south façade (Fig. 1-2) are made of typical Portuguese limestone ($\text{CaCO}_3 \approx 99$ wt%) with high open porosity (30 vol %). The remarkable amount of chlorides (at least 0.23 wt %) comes from the local marine spray and causes the overall material’s decay so evident in Fig. 2 and 3.

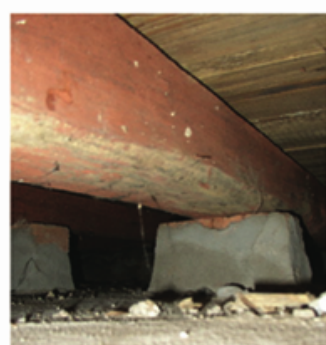
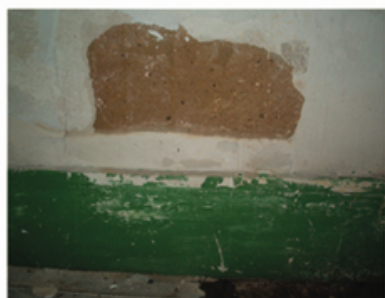
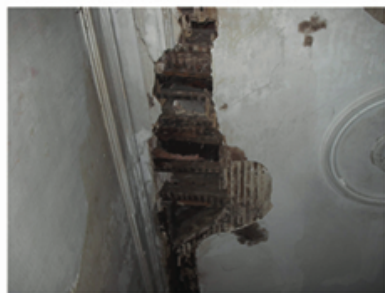
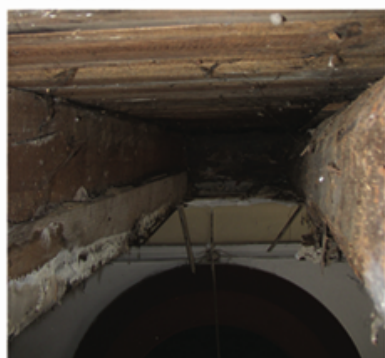
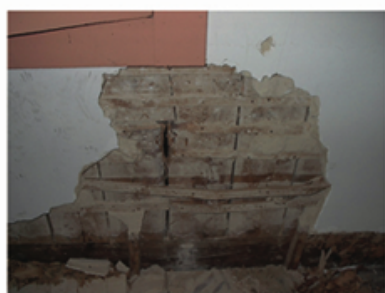
DETAIL OF THE EAST WALL
CONNECTION WITH THE GROUND
AND FIRST FLOORS

- Load bearing walls (mid-walls, perpendicular to the façades) with a large diversity in thickness and materials: adobe, brick masonry, *tabique de fasquio* (a wood structural wall covered with plaster);
- Façade composed by heavy limestone blocks, laboriously hand-carved, supported by slim stone columns at the ground floor;
- Wood as main structural material for roof (covered by Marseilles tiles);
- Floors constituted of wood beams parallel to the façades, bearing directly on the lateral walls.

In fact, during the inspections to the building, it was observed that the façades were completely detached from the adobe structural walls, due to differential creep, on the one hand, and to the foundations settlement, on the other hand. The poor soil foundation conditions in this point of the city of Aveiro must be remarked.

Thus, considering all these aspects and constraints, for the structural rehabilitation design of the building the following measures were recommended: on the one hand, to create a secondary system to connect the existing vertical components (adobe load-bearing walls and façades) and, on the other hand, to improve the global safety of the building to lateral loads, as those induced by vibrations, earthquakes and wind. A steel structural frame system, founded on piles, was adopted, which was completely embedded in the existing adobe walls, not to change the original architecture of the building.

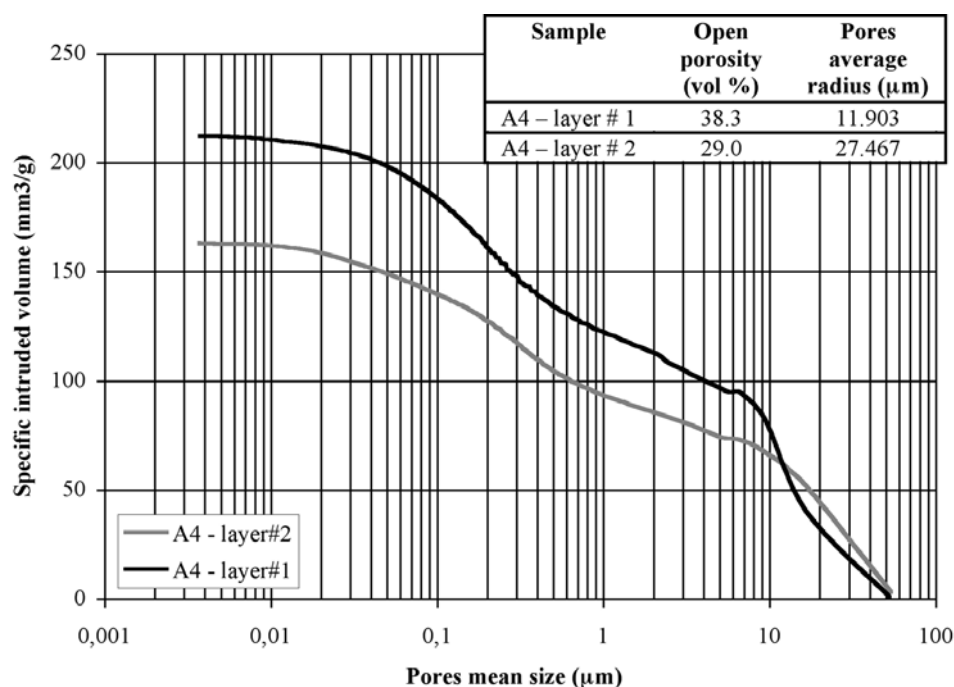
Figure 5: Casa Major Pessoa: pore size distribution in the layers 1 and 2 of A4 plaster

The plasters (Table 1) exhibited a great homogeneity: they are all made of lime binder with quartz sand (only scarce feldspar traces) and are characterised by large thickness (up to about 5 cm, Table 1) and high porosity (see, e. g., Fig. 5). The macropores are very abundant in the plasters, also due to the low amount of binder: after manual disaggregation only 15 wt % was found below 0.1 mm (Fig. 6). Thickness and porosity seem aimed to give the wall good thermo-acoustic performances, but they give also a large thickness with low

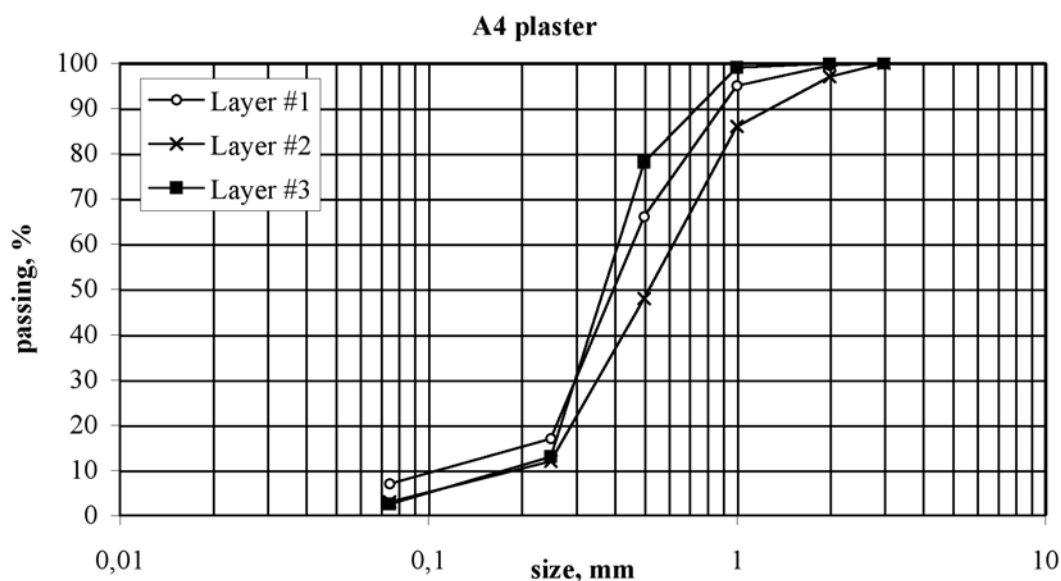
Figure 6: Casa Major Pessoa: grain size distribution in the three layers of A4 plaster

weight to the slim *tabique* walls. Accordingly, the plasters are made by different layers only to obtain strong thickness and in fact the grain size difference among the layers is negligible (Fig. 6).

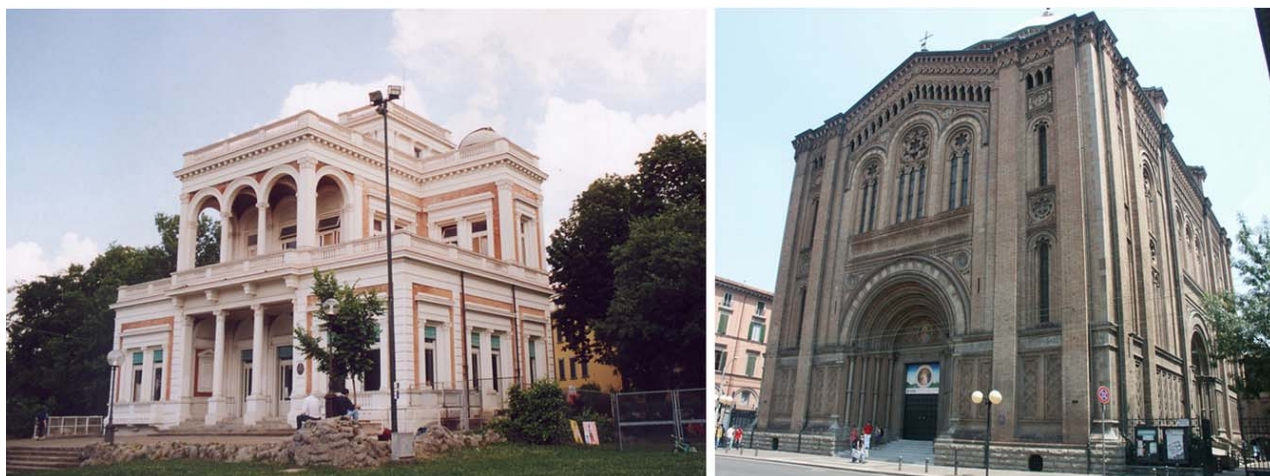
Figure 7: The *Palazzina Liberty* (left) and the *Sacro Cuore Church* (right)

Thanks to its position inside the Gardens, with scarce atmospheric pollution, the building is in fairly good state, even if some materials (masonry bricks, natural stones, finishing) exhibit decay; some recently restored parts are decayed, due to a poor compatibility between some restoration materials and the existing ones.

Although the structural state of the church is fairly good, the external surfaces are somewhat decayed (exfoliation, black crusts, disaggregation, deposits, etc.), due to the high local atmospheric pollution, caused by the heavy traffic (the church is close to the railway station).

- modern materials are present: agglomerated cement-bound stones in the internal stairs, cement mortars and concrete in the lodge banister and other external decorative elements, often white painted (Fig. 7) in order to resemble marble (a ‘noble’ material not available locally).
- Together with modern materials, traditional and local ones are still abundant in the building. E. g., locally available sandstone was
